## 6.3 Preventing Trips: Walkways, Highlighting Trip Hazards

In order to reduce the risk of people tripping over permanent hazards or ones known to be in need of repair, they need to be clearly highlighted.

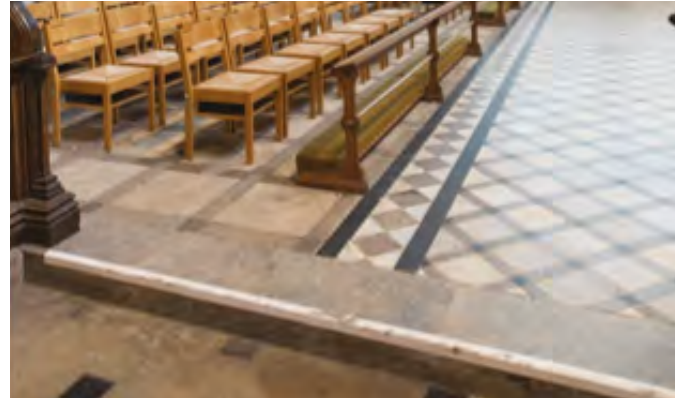
*A single step with clear nosing highlight*

- **Ensure that the highlight draws attention** to the entire raised area presenting a trip hazard, not just a small section of it or an area in the vicinity of it. The highlight should be thought of as a target that people need to be aware of so they can step over it safely. In the case of a single step for example, the highlight should be along the entire step nosing (see [module 7.0, Preventing falls on steps and stairs](#)).
- **Ensure that lighting levels around the hazard are sufficient** for it to be clearly visible (at least 50 lux).
